TNT, Satinaire or Xena Gun leaking from the Nozzle or Trigger:

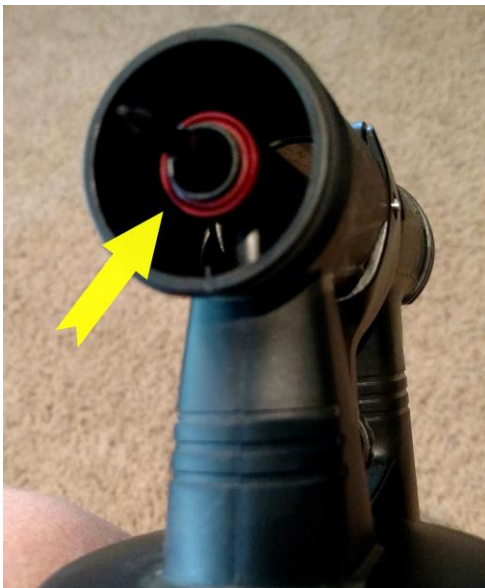
The Gasket Seal that goes on the fluid tube around the needle or inside the nozzle is lost, worn or damaged.

You have one in your spares pack, it is a small red ring.

See images below. The gun needs to be disassembled to reach this part.

Please reassemble using steps in this Document below to properly Reset the gun, or it will not function correctly
